Manhole Inspection Summary

Manhole # S19QQ_010MH

Insp Date: **7/10/07 9:04 AM**

Location Address: **1714 GWYNNS FALLS-WESTBURY** Cross Street: **REISTERSTOWN RD**

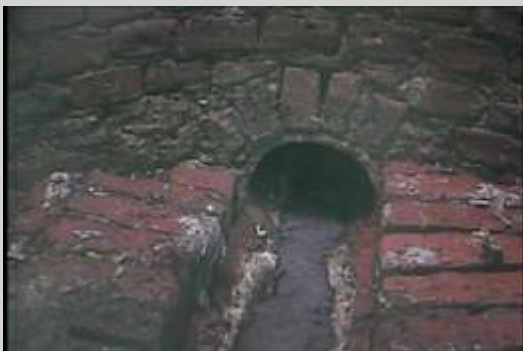
6 O'Clock Inflow

8 in. Circular Gravity Sewer
Pipe In @ 6 O'Clock

Pipe Height: **8.4** (in.) Rod and Bar (Angled)
Pipe Material: **Clay** ☐ Pipe Lined
Invert Depth: **6.99** (ft.) Flow Characteristics: **Slow**
Deposits: ☒ None ☐ Mud ☐ Sludge ☐ Debris ☐ Grease
Silt Depth: (in.) Deposits Extent:
Infiltration: **None** Pipe Seal Cond: **Sound**

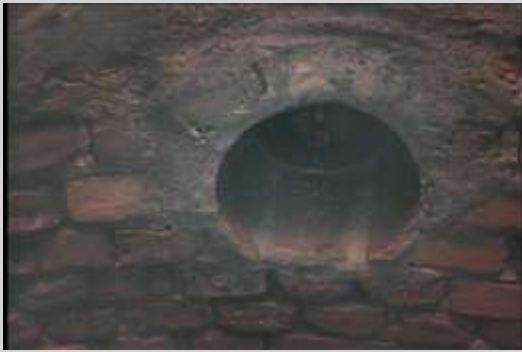
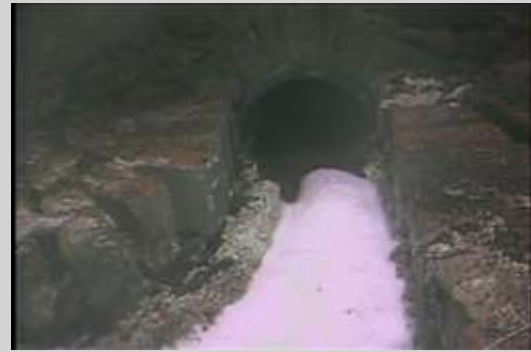
9 O'Clock Inflow

8 in. Circular Gravity Sewer

Pipe In @ 9 O'Clock

Drop In @ 9 O'Clock

Pipe Height: **8.4** (in.) Rod and Bar (Angled)

Infiltration: **None** Pipe Seal Cond: **Sound**

Drop Condition: **Open**
